# ANNUAL REPORT FOR 2005

**Marks Creek Stream Mitigation Site**  
**Wake County**  
**WBS Element 34455.4.2**  
**TIP No. R-2547WM**

Prepared By:  
Natural Environment Unit & Roadside Environmental Unit  
North Carolina Department of Transportation  
December 2005

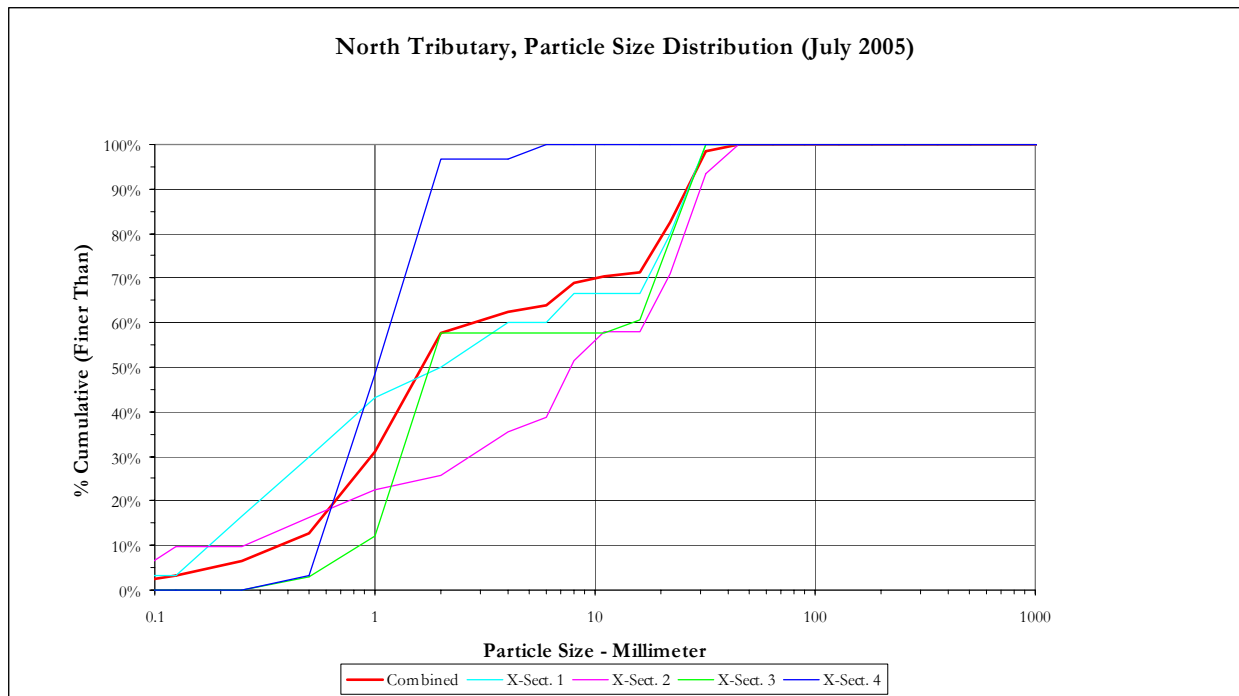
Chart 1.

Pebble counts were taken at each cross section as a means of determining the extent of change in bed material over the five year monitoring period. Comparisons between Year 2004 and Year 2005 pebble count data are shown in Table 1. The pebble counts taken during the Year 2005 monitoring period noted that the overall  $D_{50}$  (50 percent of the sampled population is equal to or finer than the representative particle diameter) decreased in size with regard to the data collected along the cross sections associated with the North, West and South Tributaries. The exceptions being the pools associated with Cross Sections #4 and #6. They remained consistent. The opposite was observed for the Southwest and Main Tributaries. Overall, the  $D_{50}$  associated with these two reaches increased in size with the exception of Cross Section #15, which decreased in size. Due to the abnormally dry year associated with 2005, sediment transport functions were likely reduced causing an increase in the amount of fines not being effectively transported through the system. Considering the intended design for this sand-bed system, the existing particle size distributions appear to be nearing the ranges originally proposed. Bedload monitoring will continue for the next several years providing a better range of data for comparison purposes.

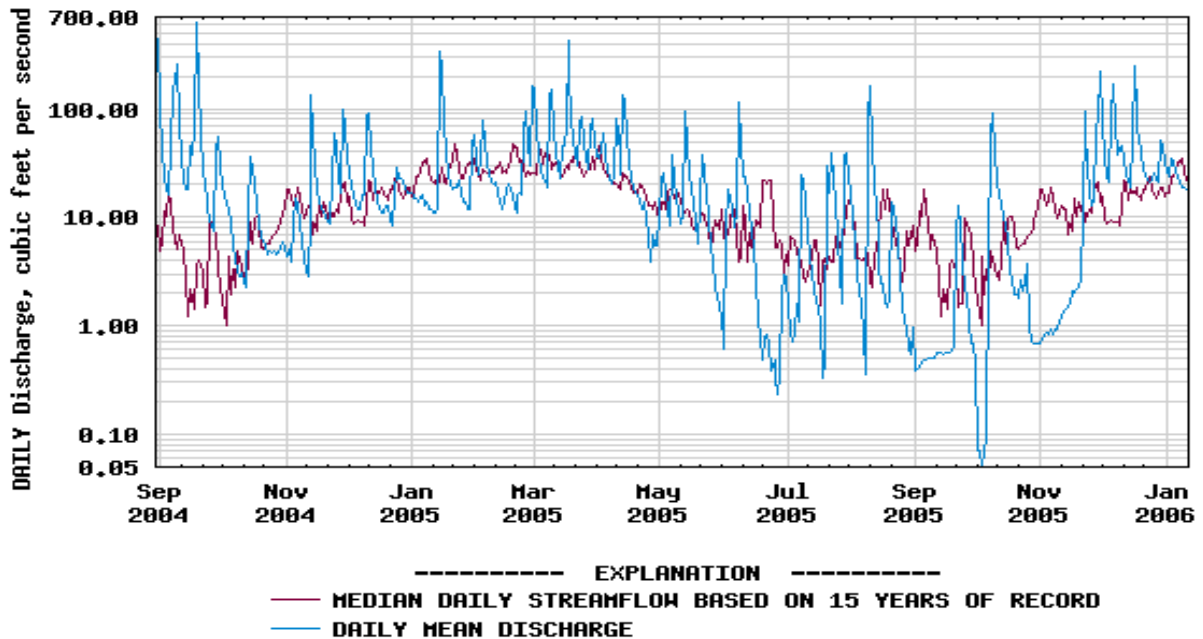
## USGS 0208758850 SWIFT CREEK NEAR MCCULLARS CROSSROADS, NC

The Swift Creek gage accurately reflects the hydrology and precipitation in the project area. It is situated in USGS Hydrologic Unit 03020201. Datum of the gage is 251.46 feet above sea level NGVD29. Based on the drainage area associated with the gage, the correlated bankfull discharge according to the NC Rural Piedmont Regional Curves (USACE, 2003) is between 770 and 1,760 cubic feet per second (cfs). Following Year 2004 monitoring activities, a review of peak flows was conducted for the period between July 2002 and July 2004. Reviews were also conducted for the Year 2005 activities. According to USGS data, Marks Creek met its requirement of two bankfull events during the first year of monitoring, with both of the events happening in 2003. The USGS graph depicting peak flows during 2005 is presented below. No bankfull events were recorded at the gage during 2005.
